OCTOBER 28, 2013

AMERICAN BASSWOOD ASSESSMENT

TUPELO NATIVE PLANT SOCIETY

JOHN HUDDLESTON
CONSULTING ARBORIST
PO Box 2444, Idyllwild, CA 92549

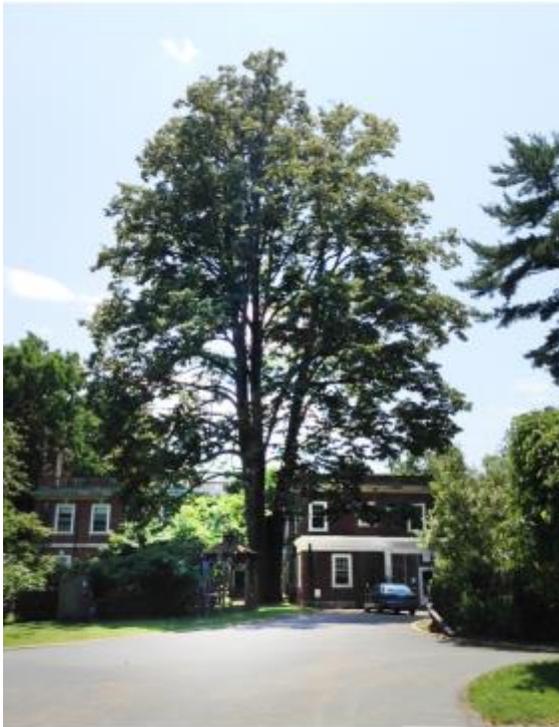
The tree is a mature American Basswood approximately 110' tall, measured with a **clinometer**, and has a canopy spread of approximately 70' (photo No.1). It has been described as a "Champion Tree" by Mrs. Ducannon. The canopy is well distributed and the **foliage** has good color. Leaf size and density is normal for the species.

Photo 1—Looking south. View of American Basswood at Tupelo Native Plant Society.

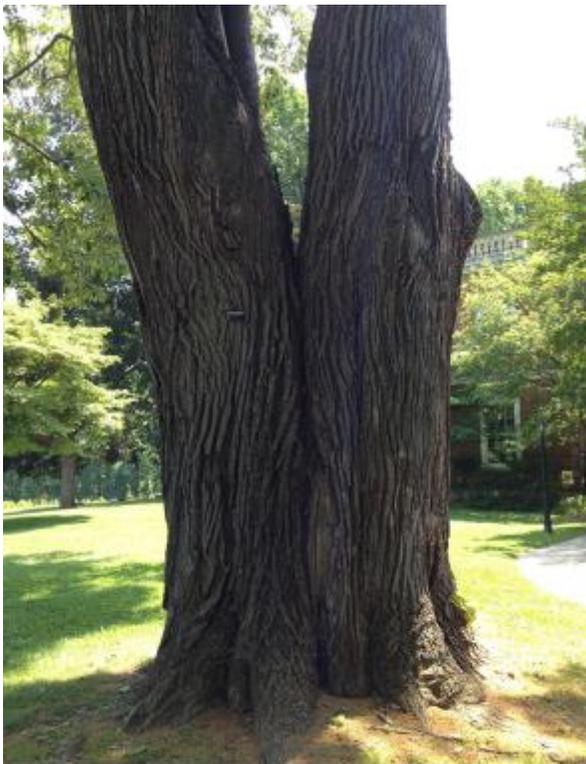
The trunk is divided at approximately six feet into two main stems, to the east and west (photos No.2 & No.3). I inserted a ¼" diameter steel probe into the inclusion and it sank freely to a depth of approximately 4.5'. There were four original leaders, two on each stem.

4. **Included bark in main stems:**

Bark inclusion is a common cause of stem failure in the Basswood. Cables were installed 10 years ago to help mitigate this risk, but their orientation and design is not sufficient for the trees current stature^{xiv}. In the possible event of stem failure, likelihood of impact to cars in the parking lot is medium. Their combination is unlikely though, and even combined with the severe consequence the impact would have on the cars, represents a low risk.

Photo 2—The two stems of the tree, north side.

Removal of the SE leader and installation of additional cables will sufficiently reduce the risk of the main leaders to nearby targets. The installation of a new cable system will also sufficiently reduce the risk posed by the included bark in the main stems for a period of time.^{xix}

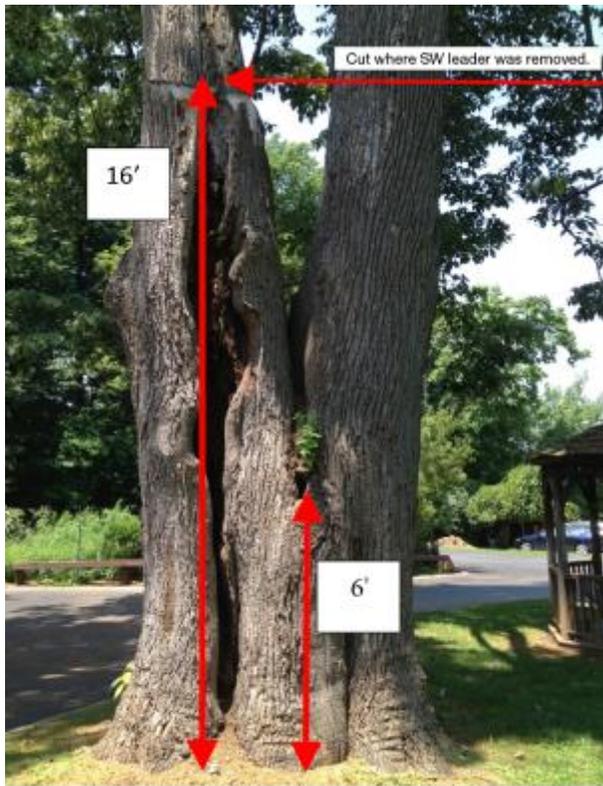
Photo 3—Trunk showing cavity from south side.

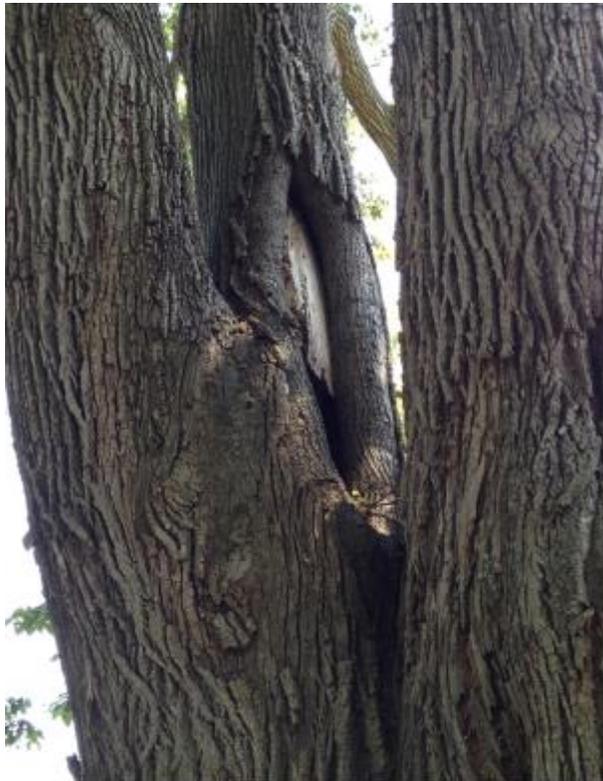
The two leaders on the eastern stem are oriented to the southeast (SE) and northeast (NE). I employed a ladder to further investigate a cavity that exists at the base of the SE leader, at approximately 15.5' above the ground. It is approximately 3' in length, 8" wide, 6" deep, and extends 12" into the stem below the point of separation from the other stem (photo No.4). Foliage above this point is thick and growth is average compared to the rest of the tree. I **sounded** the trunk below the apparent termination of the cavity with a mallet in a rudimentary test to detect unseen decay, and the remaining trunk sounded solid. A Resistograph™ would provide more reliable and quantifiable data that might change this conclusion.

3. **SE leader above cavity:**

The Basswood is considered a soft wooded tree, so the likelihood of failure of this leader over the next year is probable. Combining that with the high likelihood of impact with the building we can determine that it is likely the tree will impact the target over the next year. The consequences of such an impact would be significant, and so we will consider this defect to be a high risk.

Photo 4—Cavity in the SE stem.

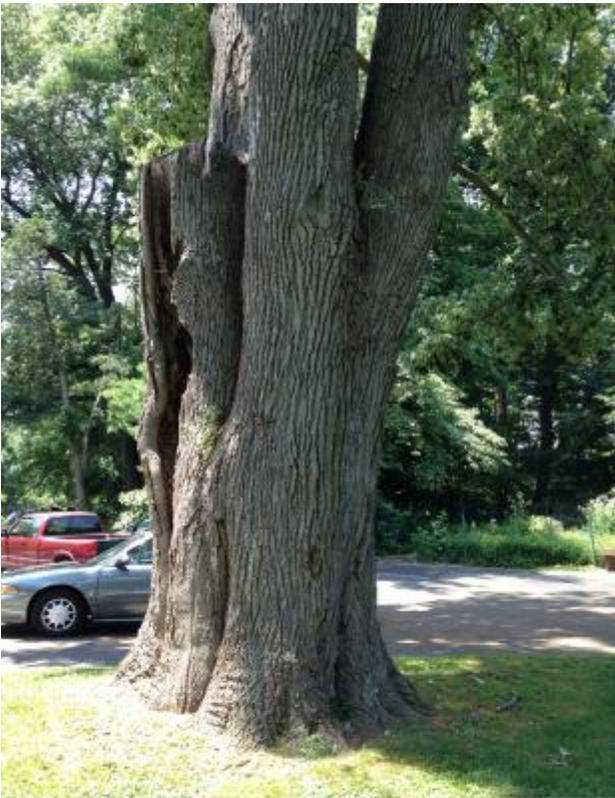
Photo 5—East side of tree.

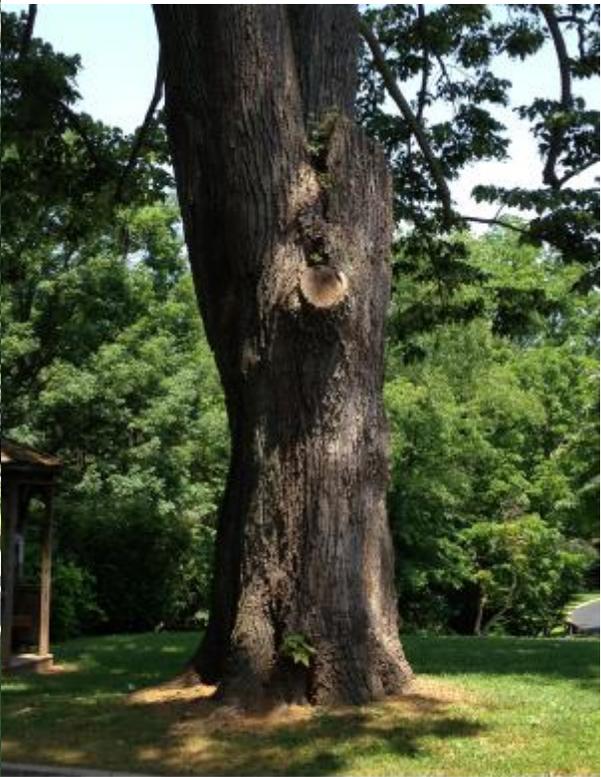
Photo 6—West side of tree.
